Hot Springs Canyon Fish and Amphibian Monitoring, 2014

October 27, 2014

Summary

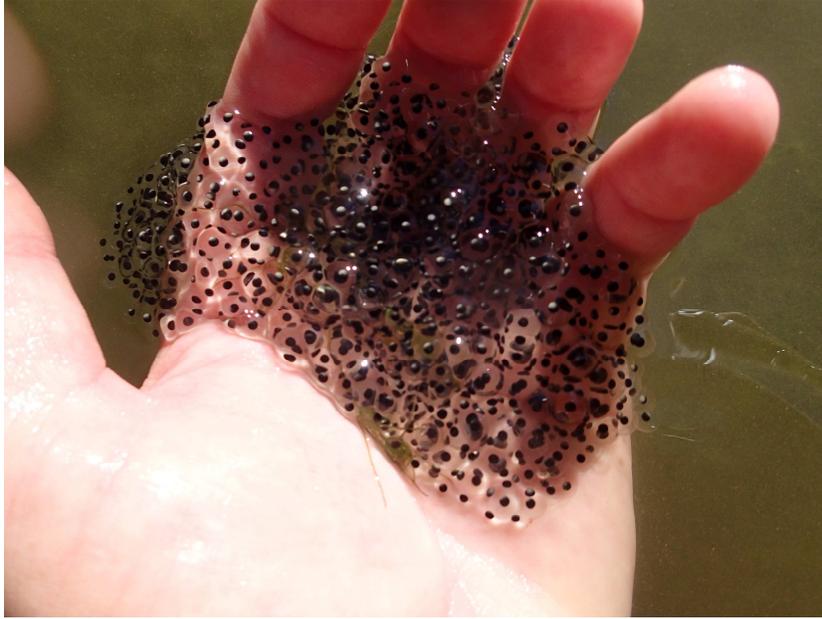
Multiple confirmed adult lowland leopard frog adults were captured or observed; most were seen downstream from the barrier. One frog egg mass (Fig. 1) was found associated with aquatic vegetation at the margin of the plunge pool below the barrier; species could not be reliably determined. No tadpoles were encountered, although this life stage could potentially be present at this time of year (Brennan and Holycross 2006). A single non-native bullfrog carcass (desiccated) was observed below the barrier but no live individuals were encountered. Several live bullfrog adults were observed near the barrier site during 2013 monitoring for the first time (Marsh and Marsh 2013).

Fig. 1. Hot Springs Canyon, Cochise Co., Arizona. Amphibian egg mass found associated with aquatic vegetation in the plunge pool below the constructed fish barrier; October 16, 2014.

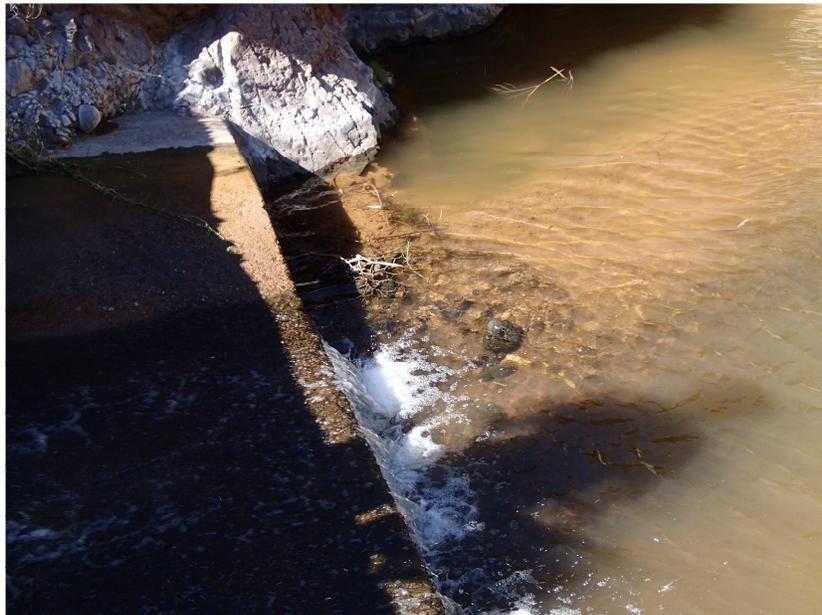
The barrier structure was carefully inspected and photographed. Wire gabion on both sides immediately downstream of the apron was exposed (e.g., Fig. 2); this condition is unchanged from previous visits. The structure itself appeared intact and there was no evidence of cracking or other failure, or of erosion of material. However, access around the barrier now requires difficult scaling of the near-vertical adjacent bedrock walls or wading/swimming through the deep scour hole below the barrier. This is because the channel bed has been lowered by removal of stream sediments across the entire stream width between the walls immediately downstream of the barrier apron.

Fig. 2. Hot Springs Canyon, Cochise Co., Arizona, showing exposed wire gabion at the base of the constructed fish barrier apron on river left; October 16, 2014.
